Manhole Inspection Summary

Manhole # S35KK_018MH

Insp Date: **3/8/07 1:49 PM**

Location Address: **300 NORTH AVE**

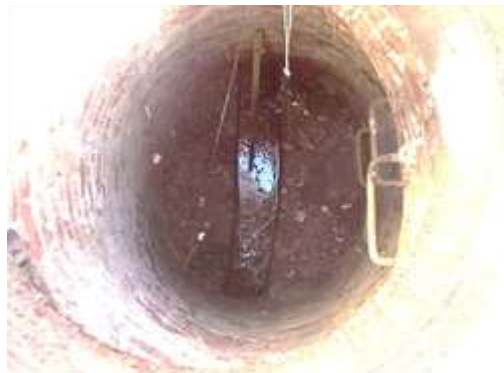
Top View

Corroded steps. Evidence of surcharge - Channel debris.

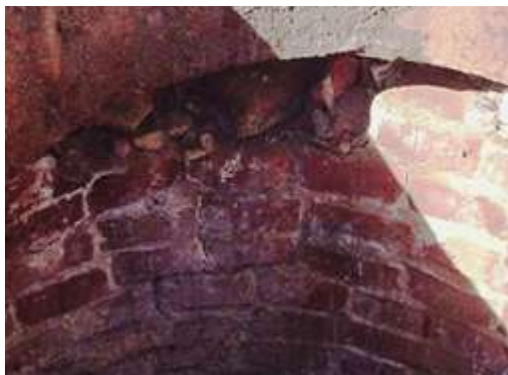
Defect

Frame leaks. Frame offset. Corbel deterioration and infiltration - other side.

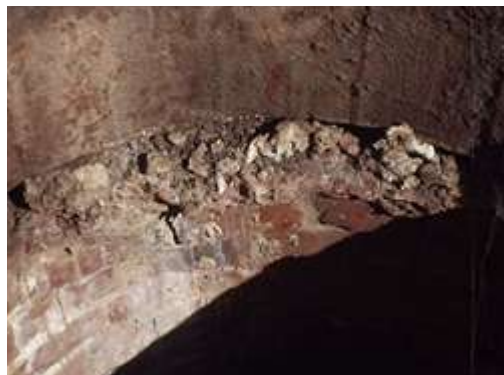
Defect

Frame leaks. Frame offset. Corbel deterioration and infiltration.

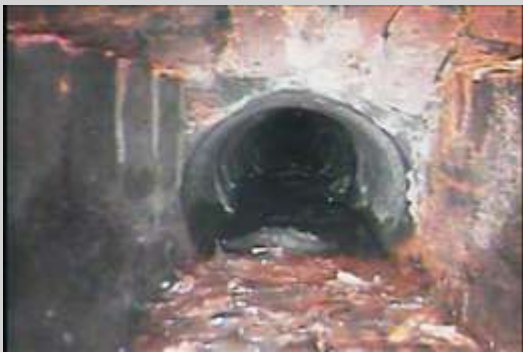
8 in. Circular Gravity Sewer Pipe Out @ 12 O'Clock

Deposits: ☐ None ☐ **Mud** ☐ Sludge ☒ **Debris** ☒ **Grease**

Silt Depth: **0.5** (in.) Deposits Extent: **Light**

Infiltration: **Evidence** Pipe Seal Cond: **Unknown**

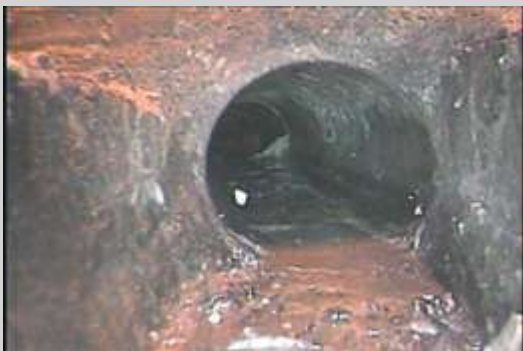
8 in. Circular Gravity Sewer Pipe In @ 6 O'Clock

Deposits: ☐ None ☒ **Mud** ☐ Sludge ☒ **Debris** ☒ **Grease**

Silt Depth: **0.5** (in.) Deposits Extent: **Light**
